**Re: Rural Municipality of North Qu'Appelle No. 187
Jasmin Development Drainage Study
FINAL Report**

Jasmin Development Drainage Study

RM of North Qu'Appelle No. 187 | November 24, 2023 | 2022-6701

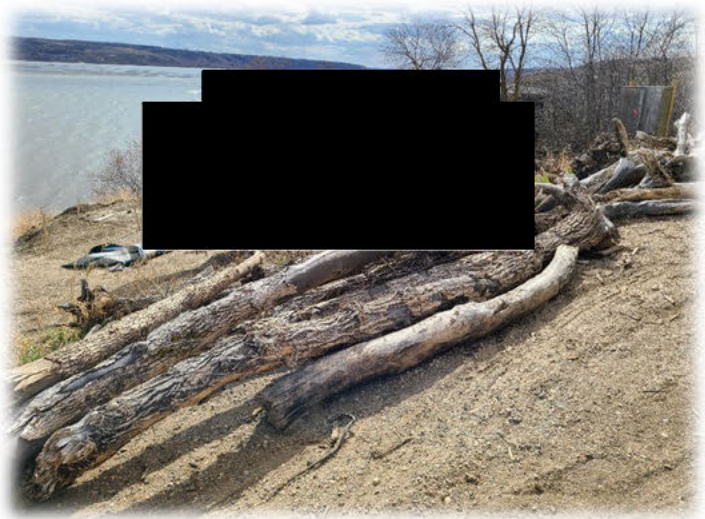
Figure 2 - Logs at West Turnaround on Pasqua Lake Road

Although the logs have been effectively redirecting the runoff, it is a significant safety concern, and prevents the turnaround from functioning as intended. Due to the placement and length of the logs, the radius remaining for the turnaround is too small for vehicles to actually complete a turnaround, resulting in three point turns in the road or using adjacent homeowner driveways.

WE recommends the ditch be deepened on the south side of the turnaround, preventing runoff from exiting the ditch. The design drawings were completed by WE, for execution by the RM to remove the logs and deepen the ditch at this location. Refer to Appendix B – Drawings. The redefined ditch should have a minimum of 100 mm of topsoil added after the new ditch is established and seeded. The turnaround is to be repaired on the south side and 50 mm of traffic gravel applied to the surface.

If the RM decided to have the works completed by a local contractor, the deepening of the ditch consists of removing approximately 40 m³ of soil. It is assumed the in-situ material can be used to repair the turnaround and excess is blended into the embankments in the surrounding area (i.e., does not require hauling offsite). The cost is expected to be approximately **\$4,000**, exclusive of applicable taxes and mobilization.

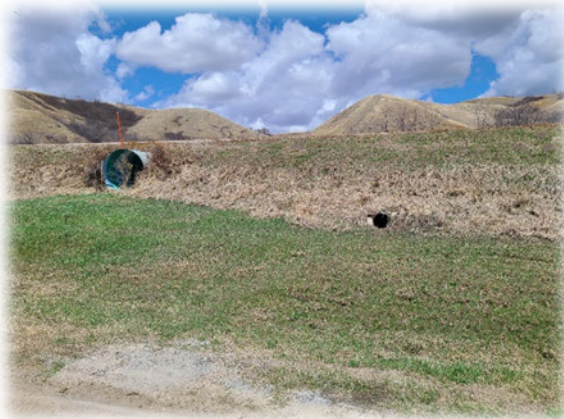
Figure 3 - 1900 mm and 450 mm Culverts North of Aaron Court

The 450 mm diameter culvert crossing Highway 56 has significant debris deposits, restricting flow. The area north of the Highway fills with water and spills to the south via the 1900 mm walkway culvert. The water from this culvert is directed over the road, Aaron Court and into [REDACTED], instead of being conveyed to the defined drainage ditch. Refer to Figures 3 and 4.

The RM should jet, flush and/or hydrovac the culvert to ensure it remains open and usable. The smaller diameter discharge will restrict flows to Aaron Courts ditch, preventing the flooding observed when being received by the 1900 mm culvert.

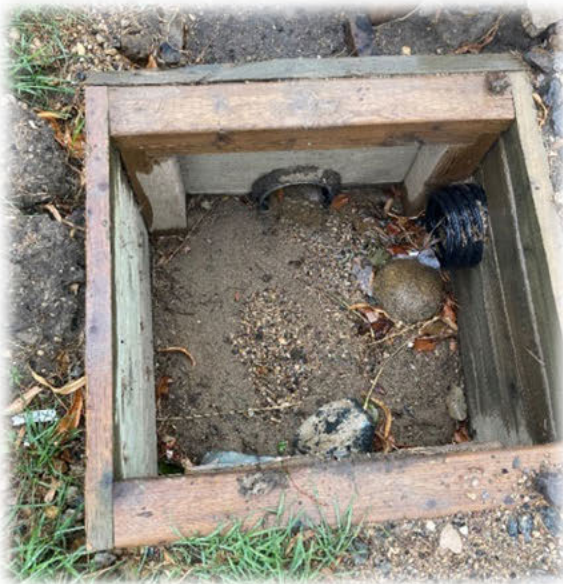
Figure 6 - Runoff Collection Box

CSP 3 transfers water from the northern side of the road to the southern side of the road and into a wooden 'drain box'. The drain box collects runoff from the 450 mm diameter culvert, as well as the surficial runoff from the adjacent driveways and weeping tile line below the western driveway. This box had one 150 mm weeping tile outlet visible, however, the lot owner indicated there are two additional 100 mm weeping tile connections below the 150 mm line, but the box had been filled in with gravel/silt over time and the lines were no longer visible; refer to Figure 6.

The weeping tile discharges to a corrugated steel pipe vertical column, where the water drops to a small diameter HDPE outlet to Echo Lake. The HDPE line passes through an existing concrete retaining wall.

Seeing that the lot Owners have made multiple attempts to jet and hydrovac the existing weeping tile lines, it is unlikely that the existing system can be rehabilitated to provide full flow. Since the current solution does not use recommended practices and cannot be rehabilitated, the most viable options for repair include:

WE would recommend the RM install **Option 1A – Surface Runoff with Armouring** with articulate blocking. This option is expected to be a robust solution that will work well in the design flow as well as larger storm events. The articulate blocking has a design life greater than 25 years, assuming the underlying mesh is covered with limited UV exposure. The blocking will prevent erosion and will provide a location for siltation to deposit. Although visible to the homeowner, we anticipate this option will be acceptable in that it still allows access from the front-yard to the backyard and is relatively aesthetic when compared to rip rap. The articulate blocking allows mowing right over top, which is easy for the homeowner to maintain in conjunction with their typical yard maintenance.
