**Re: Rural Municipality of North Qu'Appelle No. 187
Jasmin Development Drainage Study
FINAL Report**

Jasmin Development Drainage Study

RM of North Qu'Appelle No. 187 | November 24, 2023 | 2022-6701

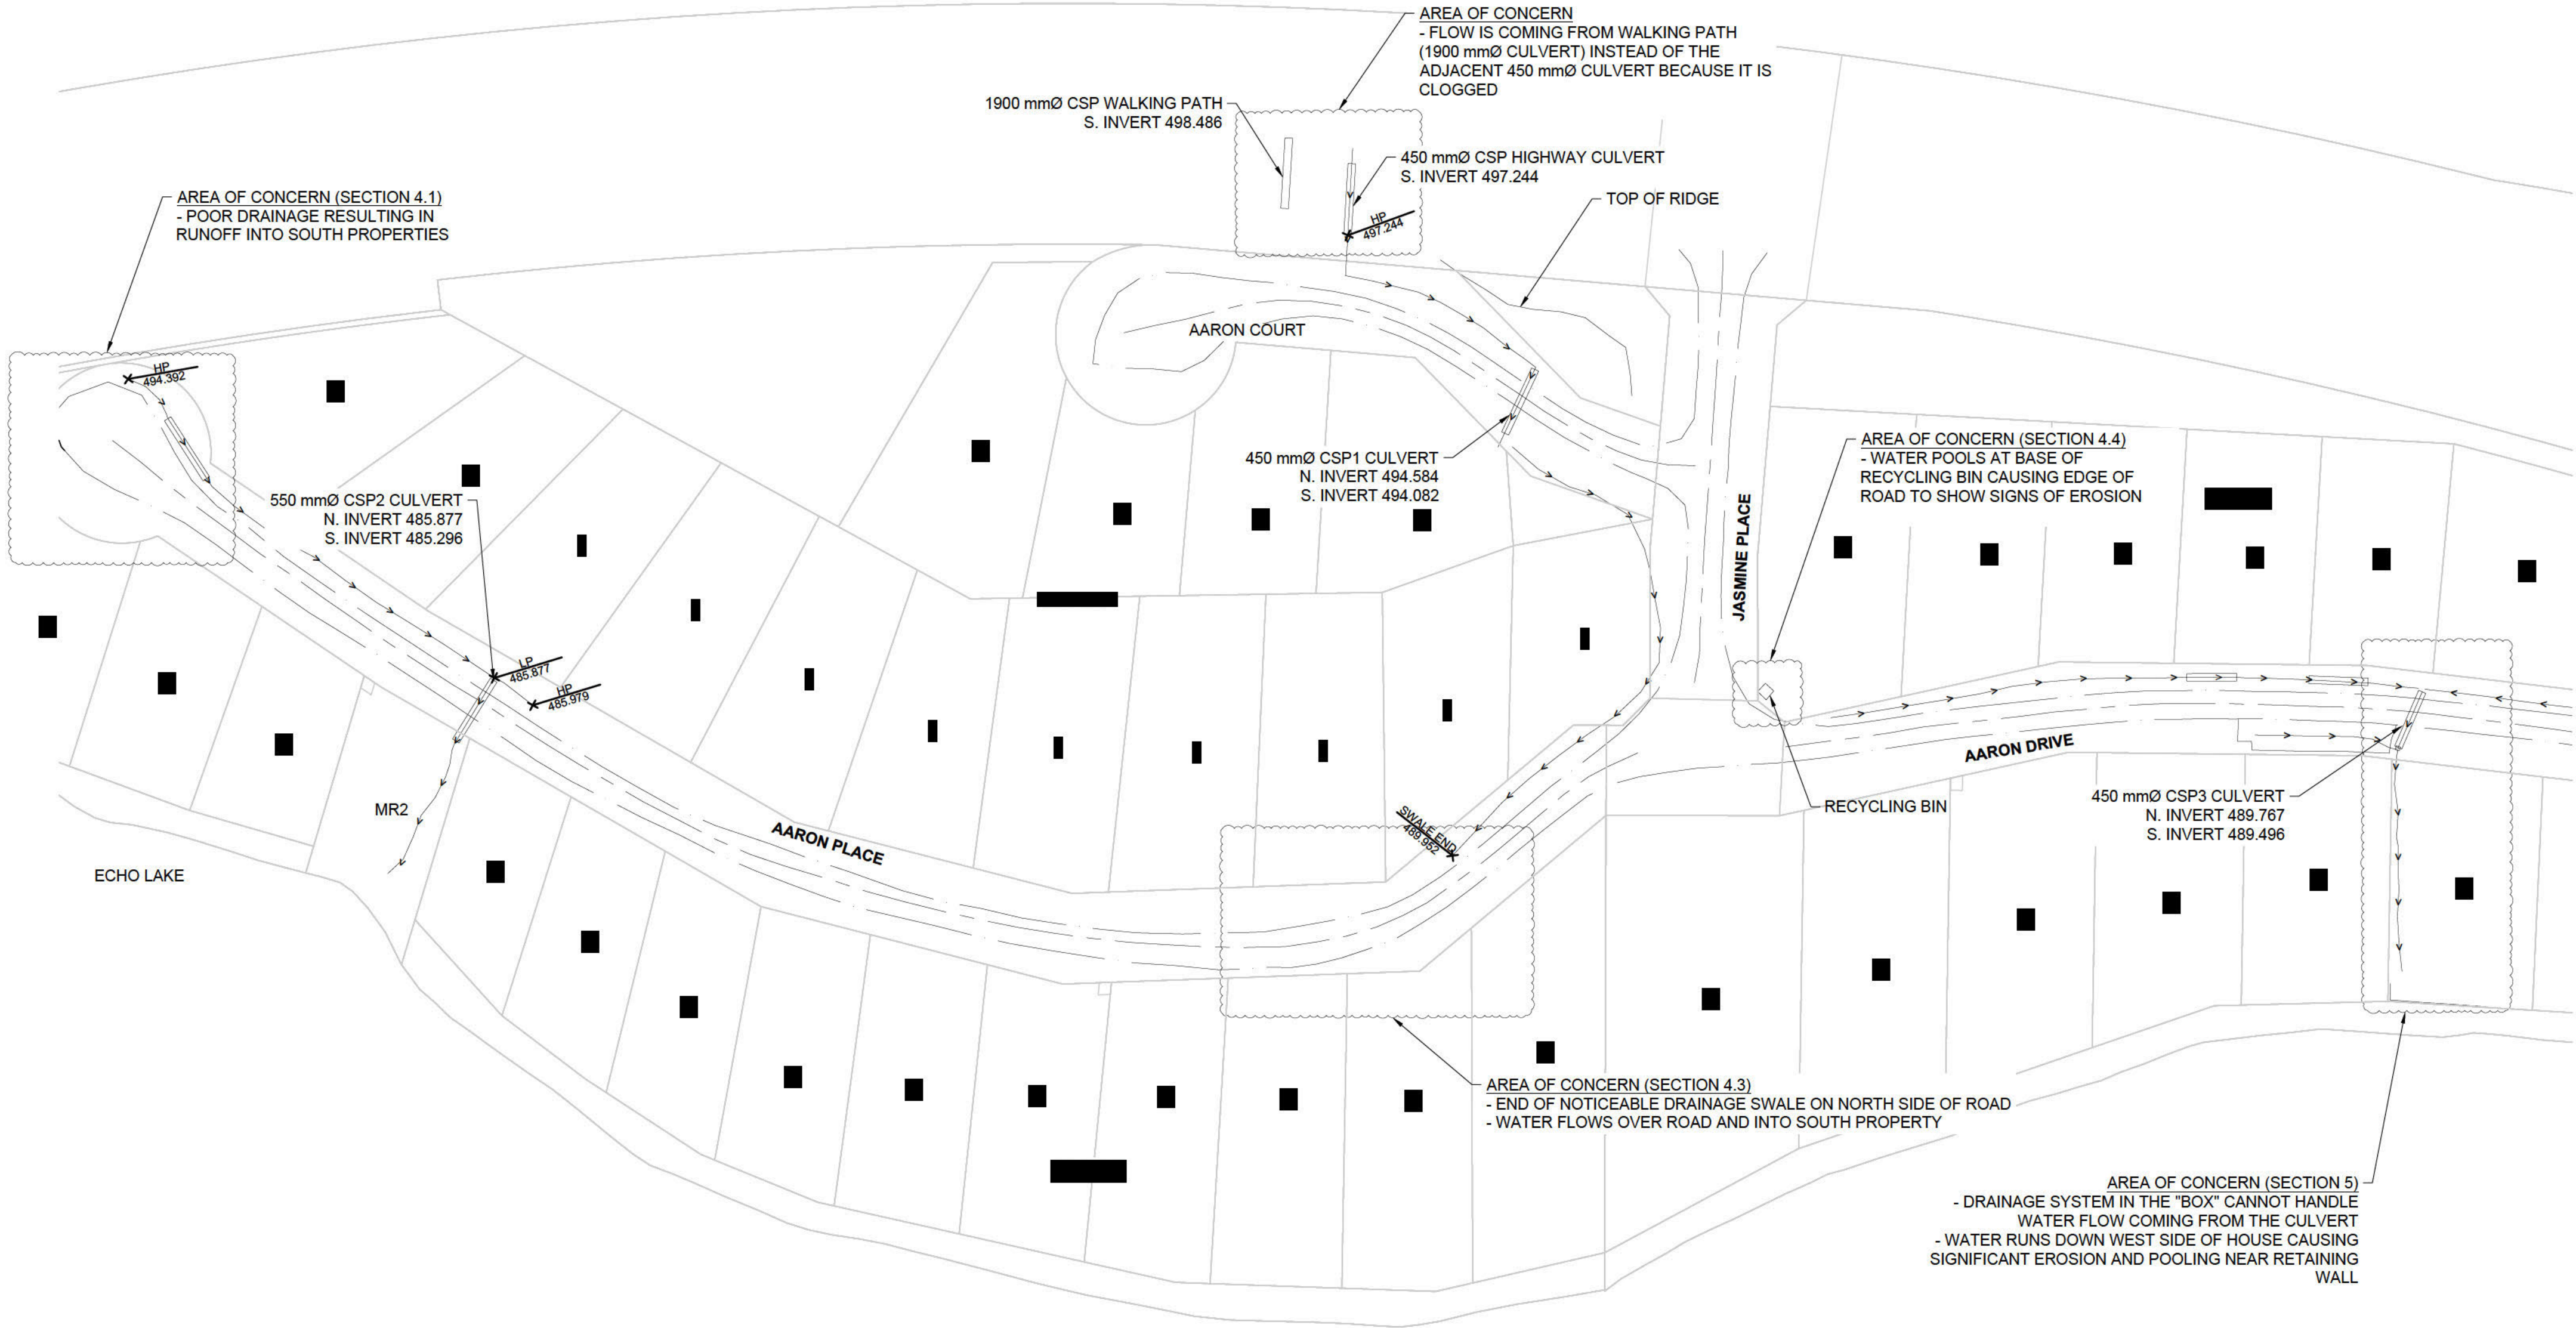
EXISTING SITE PLAN WEST

- ◆ There is ponding on the southwest corner of [REDACTED]
- ◆ The 'drain box' receiving flow from CSP 3 between [REDACTED] backs up, and overflows through both lots. [REDACTED] has experienced significant erosion along the side yard, which the owners have indicated they have repaired on numerous occasions. [REDACTED] has a gravel pad in their side yard for parking that washes into the backyard and settles in the artificial grass.
